Manhole Inspection Summary

Manhole # S39Y1_034MH

Insp Date: **11/16/07 10:35 AM**

Location Address: **539 Cambria St**

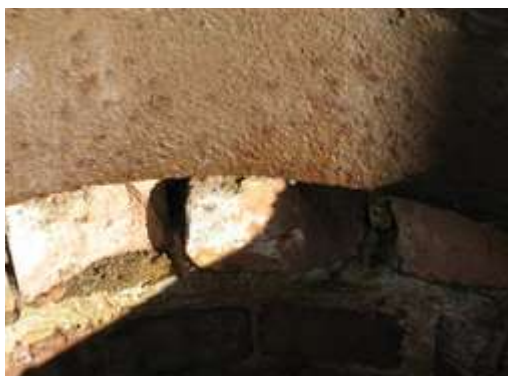
Defect 1

Condition: ☐ Sound ☐ Cracked ☐ Root Intrusion ☒ **Loose Brick** ☐ Deteriorated

loose bricks on chimney

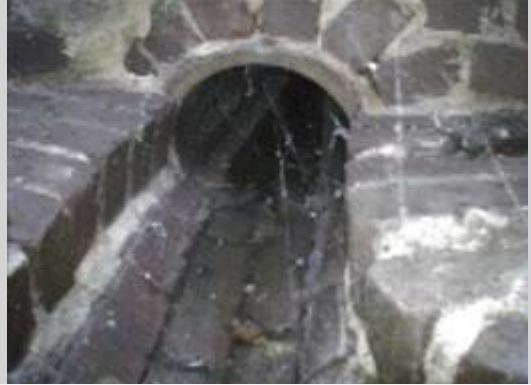
12 O'Clock Outflow

8 in. Circular Gravity Sewer
Pipe Out @ 12 O'Clock

Pipe Height: **10.8** (in.) Rod and Bar (Angled)
Pipe Material: **Clay** ☐ Pipe Lined
Invert Depth: **9.16** (ft.) Flow Characteristics: **None**
Deposits: ☒ None ☐ Mud ☐ Sludge ☐ Debris ☐ Grease
Silt Depth: (in.) Deposits Extent:
Infiltration: **None** Pipe Seal Cond: **Sound**

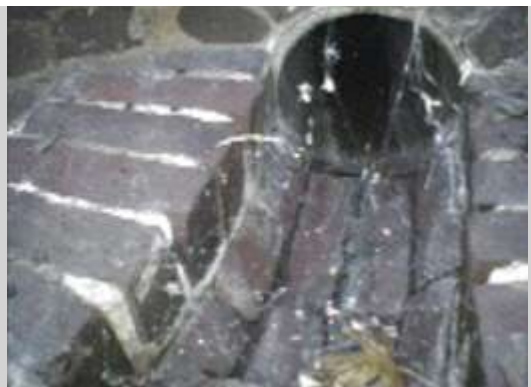
3 O'Clock Inflow

8 in. Circular Gravity Sewer
Pipe In @ 3 O'Clock

Pipe Height: **9.6** (in.) Rod and Bar (Angled)
Pipe Material: **Clay** ☐ Pipe Lined
Invert Depth: **8.78** (ft.) Flow Characteristics: **None**
Deposits: ☒ None ☐ Mud ☐ Sludge ☐ Debris ☐ Grease
Silt Depth: (in.) Deposits Extent:
Infiltration: **None** Pipe Seal Cond: **Sound**

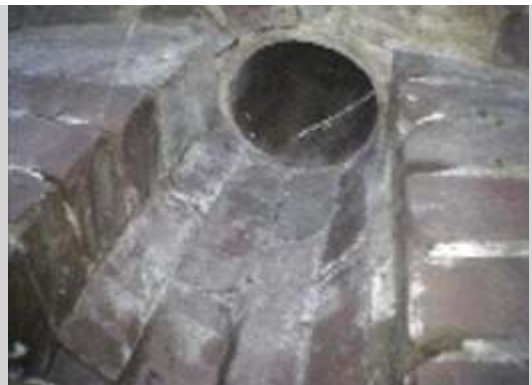
6 O'Clock Inflow

6 in. Circular Service Sewer
Pipe In @ 6 O'Clock

Pipe Height: **7.2** (in.) Rod and Bar (Angled)

Pipe Seal Cond: **Sound**
